# **Final Report of the Transportation Safety Board of Canada**

to the aircraft McDonnell Douglas MD-11, HB-IWF (SR111)

### In-Flight Fire Leading to Collision with Water

Report Number A98H0003

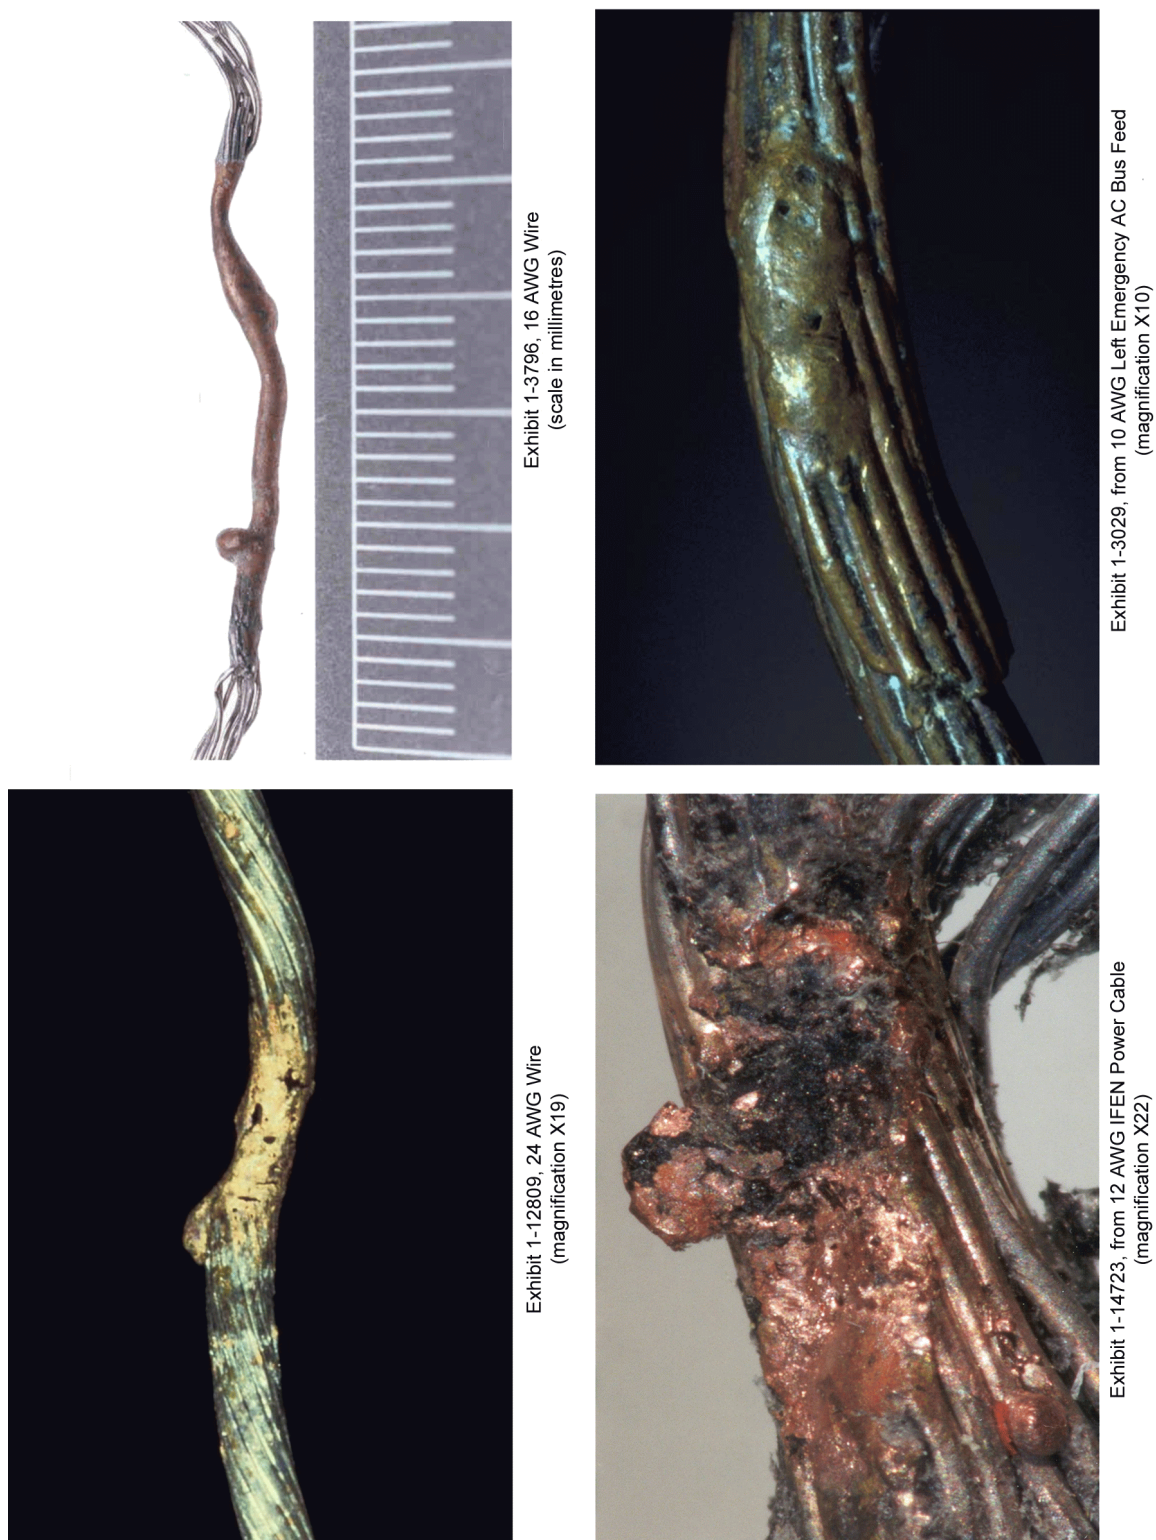
**Figure 20:** Wire segments with melted copper

All of the recovered wires were examined, primarily to identify any with signs of melted copper. As the fire did not reach temperatures high enough to melt copper,<sup>50</sup> any areas of melted copper would indicate that an electrical arcing<sup>51</sup> event had occurred.

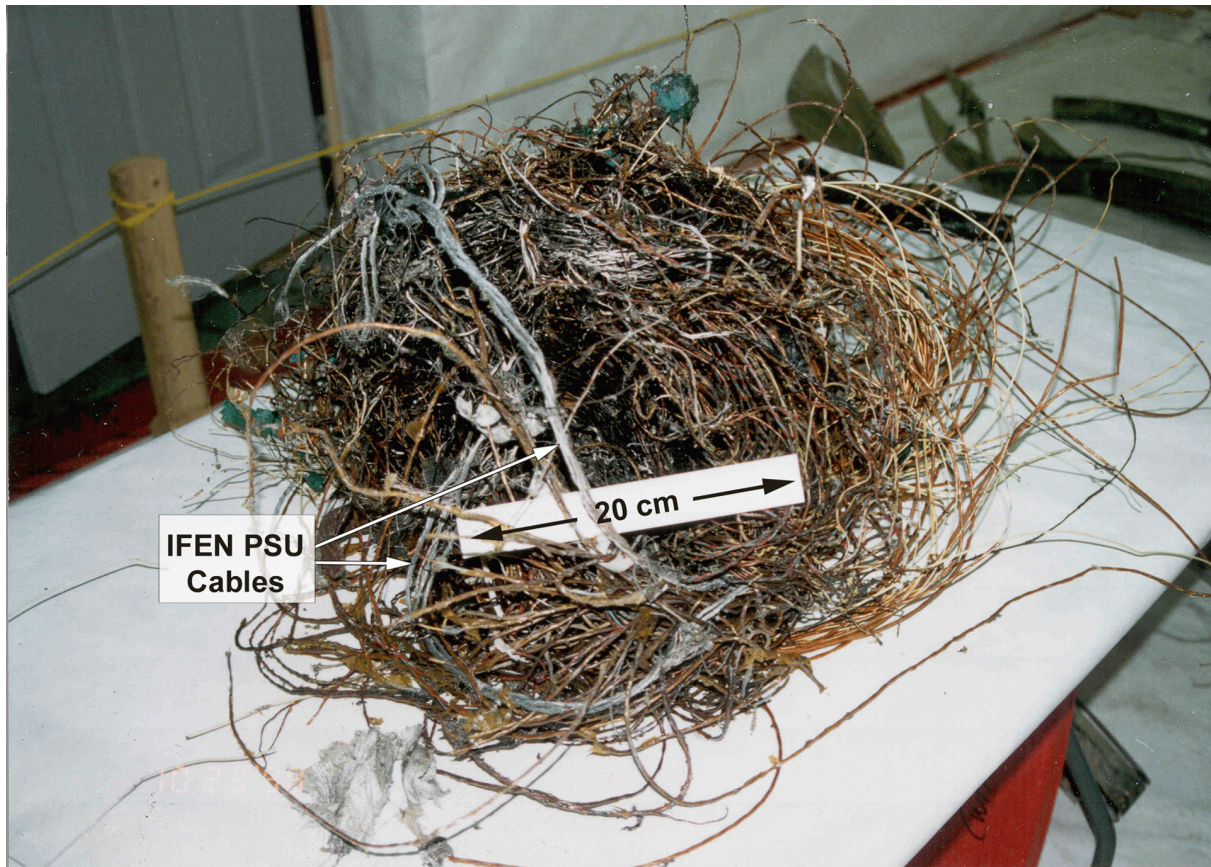
**Figure 21:** Exhibit 1-4372

Of the nine wire or cable segments with areas of melted copper that were recovered from Exhibit 1-4372, four were positively identified as being segments of the IFEN PSU cables (1-3790, 1-3791, 1-3792, and 1-3793) (see Figure 22). This identification was based on remnants of coloured ETFE insulation remaining attached to the wires. On each of these four segments, one end was heavily matted, or crushed together, and the opposite end was fractured and frayed. Exhibits 1-3790 and 1-3792 both had distinctive regions where the tin coating was missing from the wire strands on all three wires. Exhibits 1-3791 and 1-3793 did not have a similar region of missing tin.

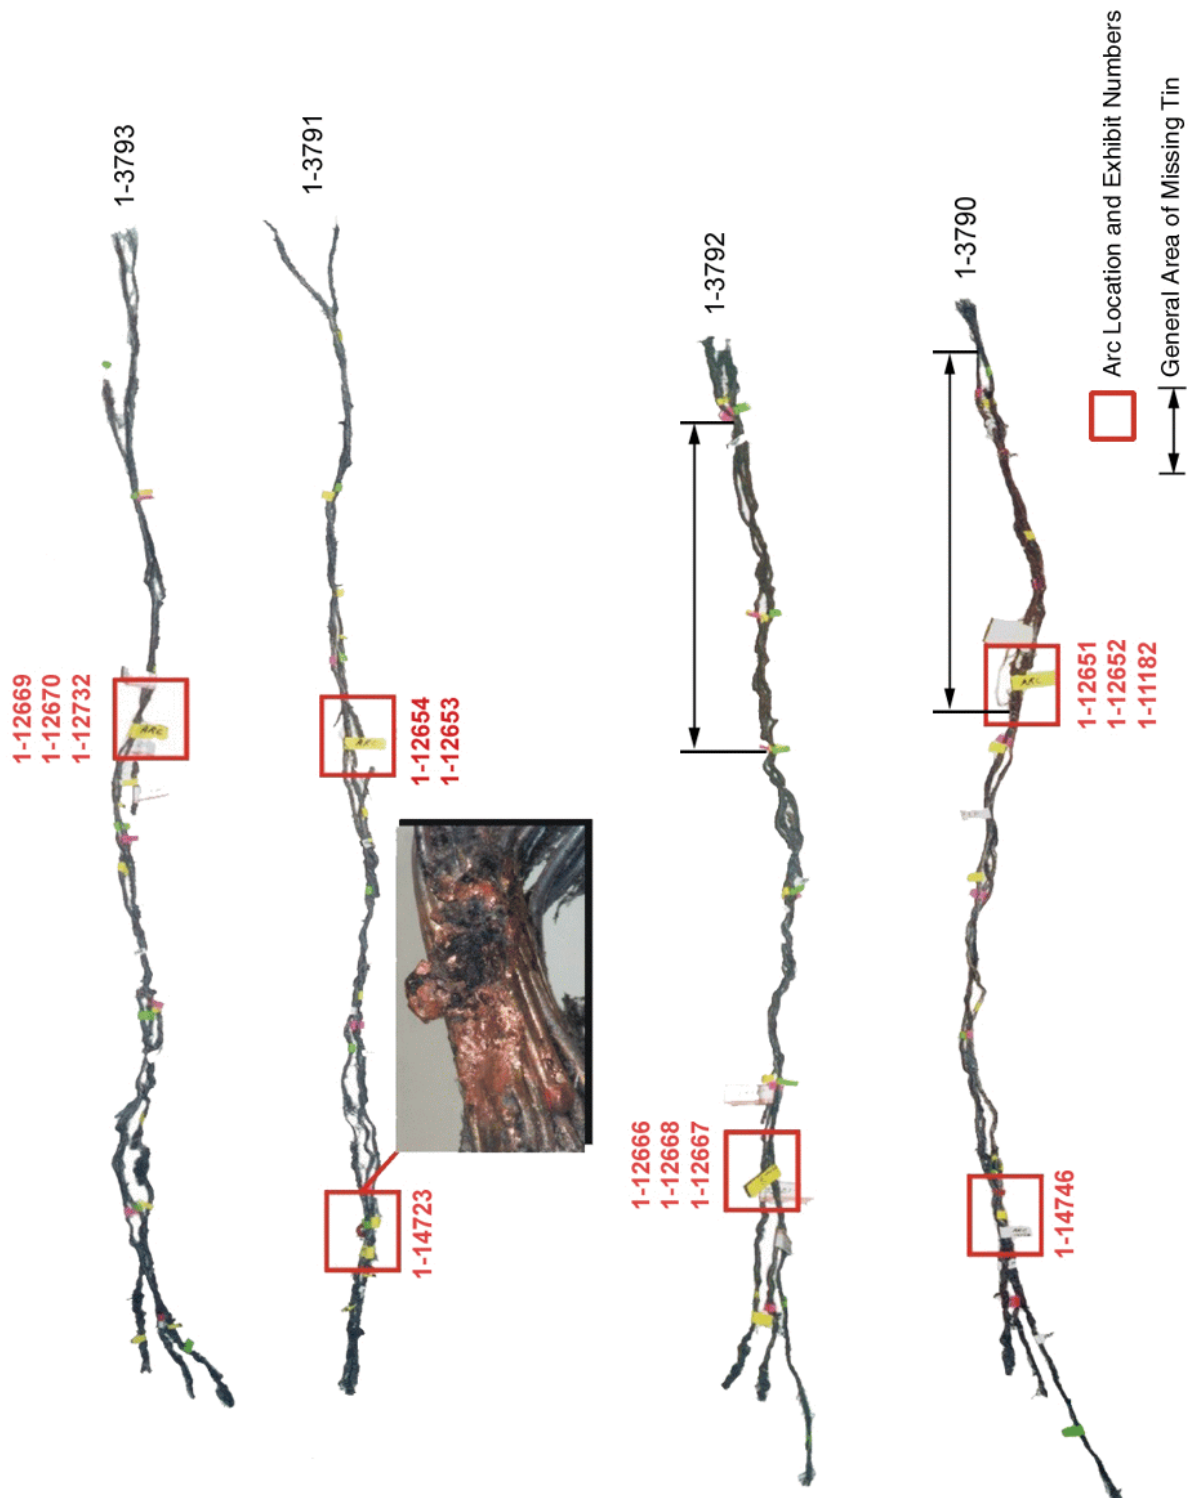
Figure 22: IFEN PSU cable segments

Of the remaining five segments, based on adhering remnants of ETFE insulation, four (1-3794, 1-3795, 1-3788, and 1-10503) were identified as segments of the 16 AWG IFEN 28 V DC control wire used to control the PSU outputs. The total length of these four segments was 97 cm (38 inches). The fifth (1-3796) was a segment of polyimide-film-insulated, nickel-coated 16 AWG wire. This wire segment could not be associated with a specific circuit; however, because it was nickel coated, it is known that it was not from the IFEN system.

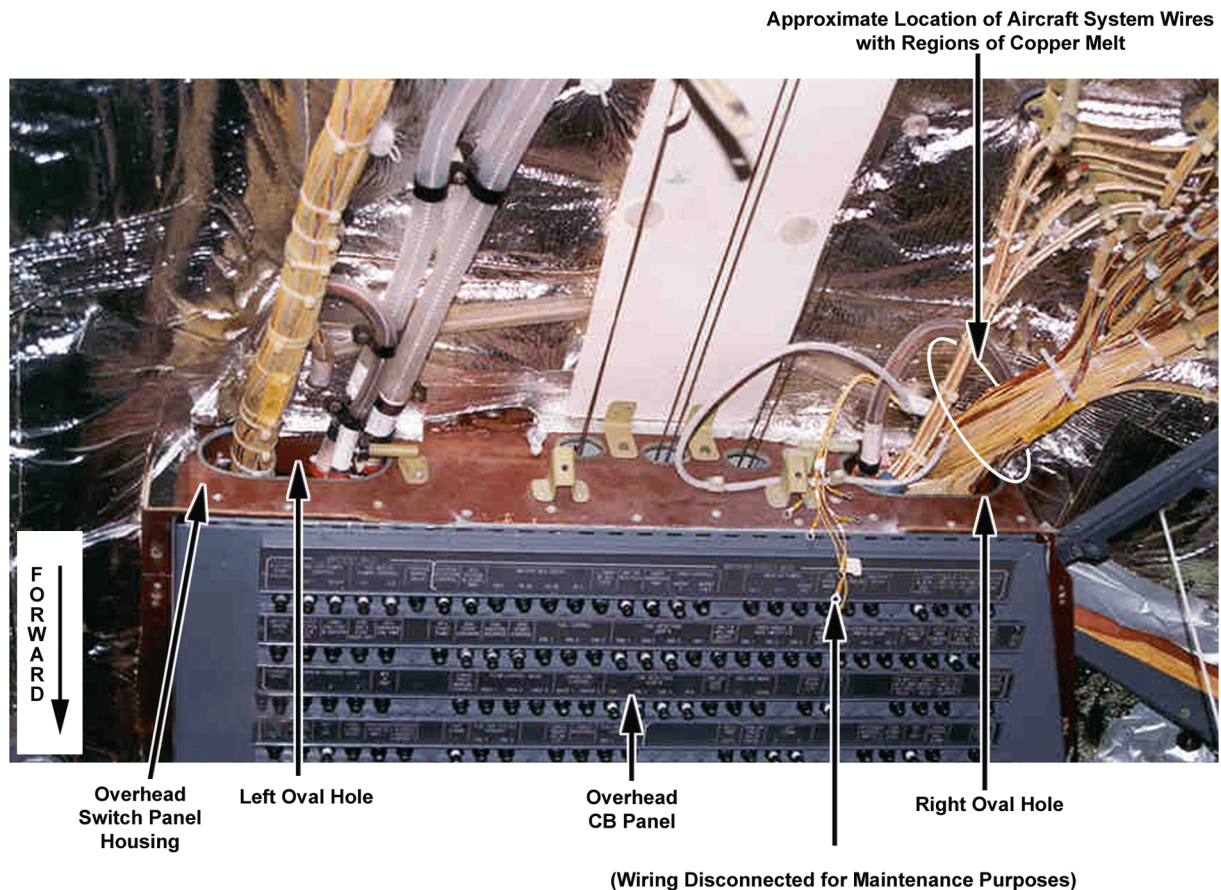
**Figure 23:** Location of identified aircraft wires with regions of copper melt

Exhibit 1-6976 consists of a segment of a 6 AWG nickel-coated, polyimide-insulated wire, approximately 102 cm (40 inches) long with the wire number B205-4-6 stamped on the insulation. This number identifies it as a segment of the left emergency DC bus feed wire. One end of the wire segment had two flag lugs attached that would have been connected to the left emergency DC bus bar located behind the overhead switch panel. The known location of the flag lug to bus bar connection allowed for this segment to be accurately located in the reconstruction mock-up. The end with the melted copper was located approximately 15 cm (6 inches) outside the right hole in the overhead CB panel housing. This placed it above the forward right side of the cockpit ceiling.

There was a 2-cm (0.8-inch) long section of resolidified copper located about 97 cm (38 inches) from the flag lugs. The nickel coating was missing from the conductor, for about 6 cm (2.4 inches) on either side of the melted area. The outer surface of the resolidified copper was smooth and did not exhibit any of the normal characteristics associated with an arcing event, such as surface porosity or irregular surface structure. Radiographs of this area showed it to be a solid mass, without voids. This was the only nickel-coated wire segment that exhibited melting of the nickel coating beyond the area of the resolidified copper. This melted copper was considered to have been the direct result of a welding operation during the manufacturing process of the wire.<sup>57</sup>

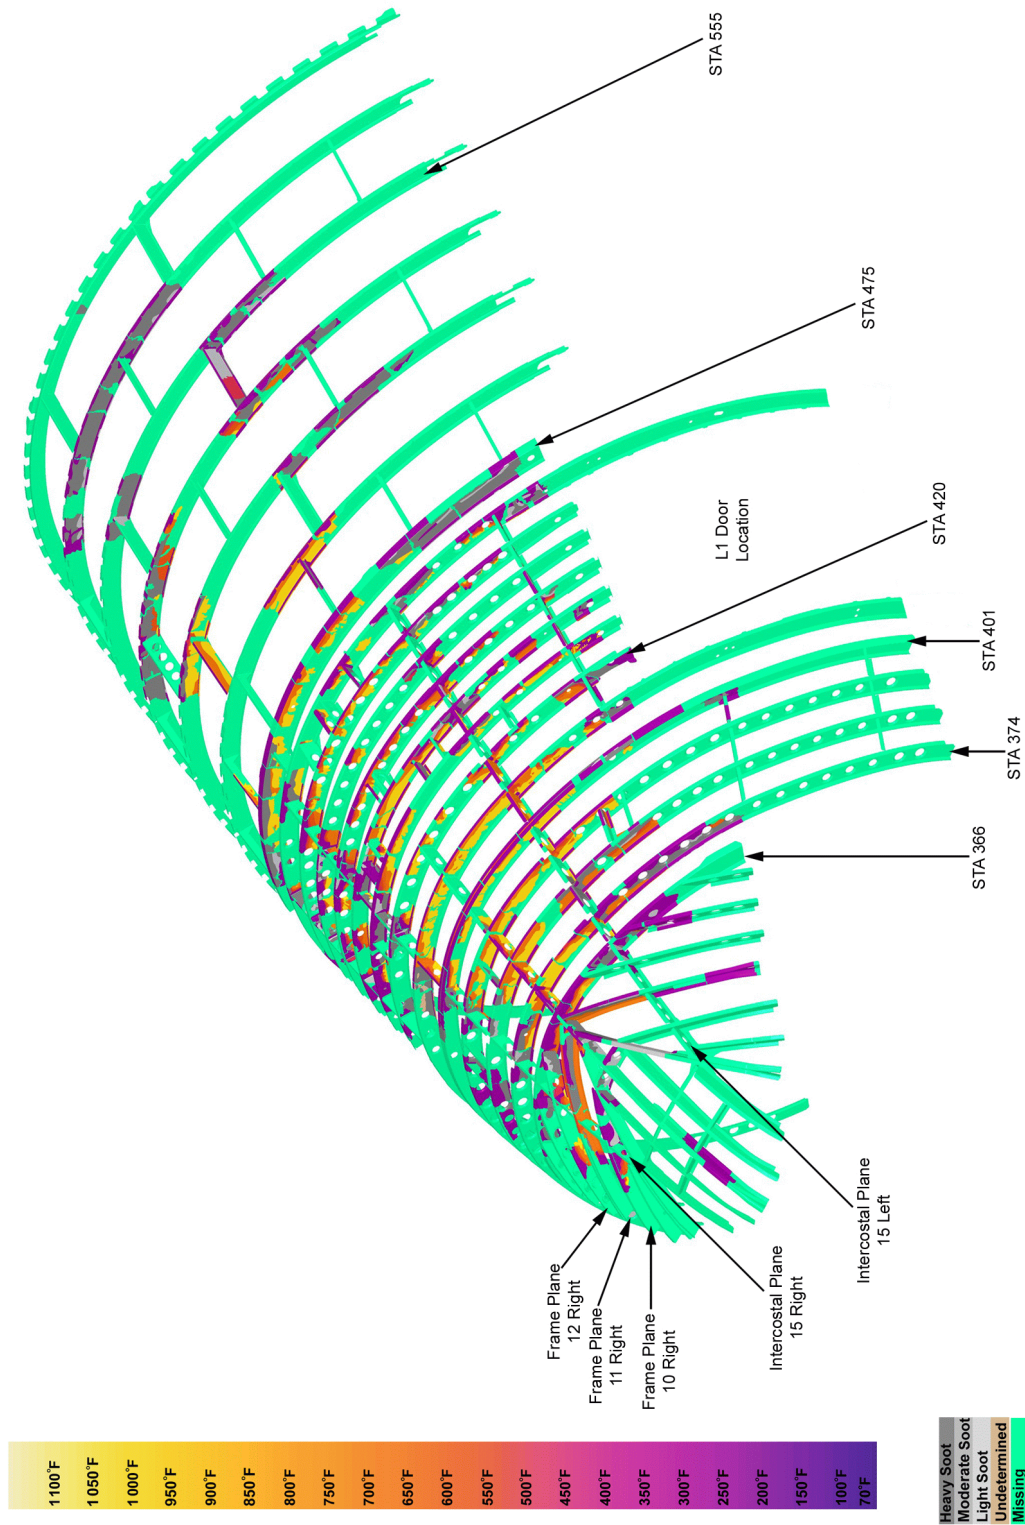
Figure 25: Heat damage – airframe structure

Damage to the riser duct assembly ranged from no heat damage to bare-metal heat damage. The vertical portion of this assembly had no heat damage. The first area of bare-metal damage to the riser duct assembly started at intercostal plane 15 right, where the lower surface had a region of bare-metal heat damage from  $X = -30$  inboard to the joint at  $X = -20$ . This was in the vicinity of the Galley 2 vent end cap. There was bare-metal damage from approximately STA 395 to STA 442 between  $X = 25$  and  $X = -10$ . A section of molded duct was installed in that area from STA 420 to STA 442 between  $X = 5$  and  $X = 25$ . No portions of this molded duct were identified in the wreckage.

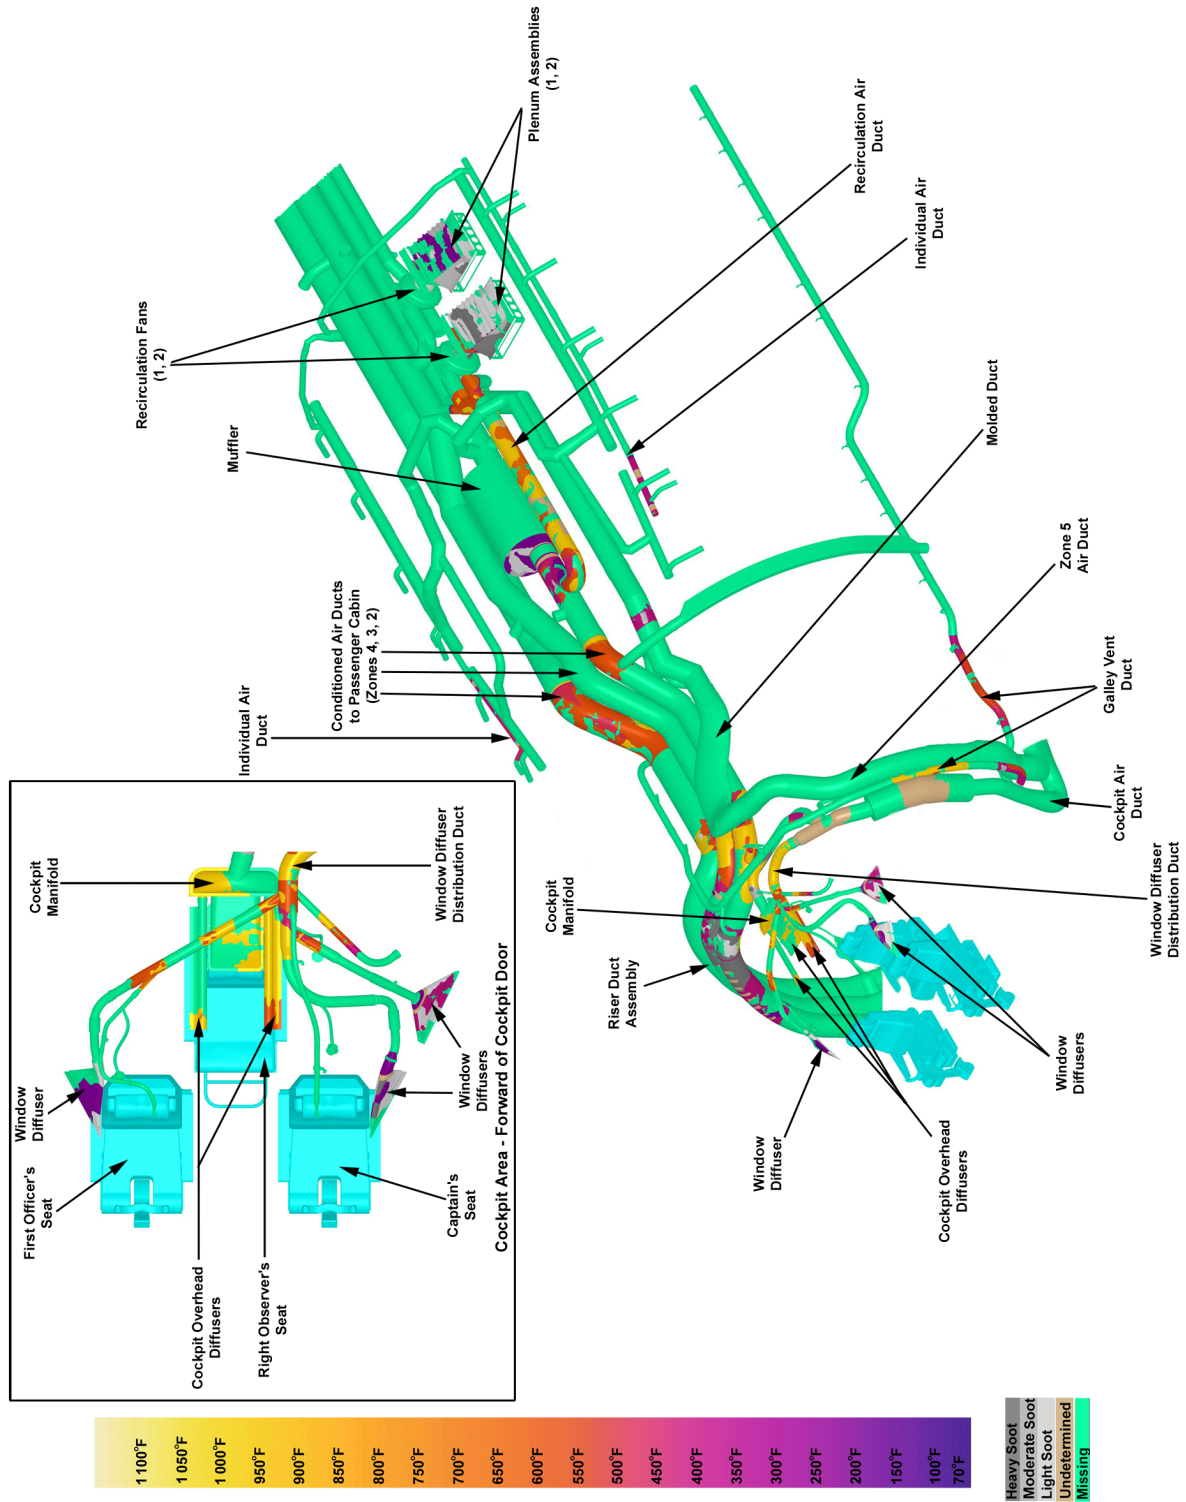
Figure 26: Heat damage – air distribution system

Between approximately STA 480 and STA 545, the main conditioned air ducts for zones 2, 3, and 4 transitioned from running near the top of the forward cabin drop-ceiling, upward to run near the crown of the aircraft. In this area there was bare-metal heat damage at places along the top of the ducts. The primer on the underside of these ducts was not damaged by heat. The recovered portions of two individual air ducts from approximately STA 555 to STA 595 at  $X = 70$  and  $X = -70$  had areas of light to moderate soot accumulation.

Forward passenger cabin individual air was supplied by a fan and plenum assembly identical to a recirculation air fan and plenum assembly. The fan was located at STA 990 at  $X = -24$ . The plenum assembly was between  $X = -40$  and  $X = -65$ . The recovered portions of the plenum had no heat damage or soot accumulation. The individual air ducts were uninsulated and ran forward from STA 990 to a "Y" (split) at STA 750 at  $Z = 91$ ,  $X = -21$ . One branch of the "Y" ran across the crown to the left side of the cabin at  $X = 76$ , and the other ran to the right side at  $X = -76$ . The recovered portions of these ducts had moderate to heavy soot accumulations on the exterior, with no heat damage. The aftermost section of individual air duct that was identified was from STA 934 to STA 955 at  $X = -22$  and had light soot accumulation on the exterior.

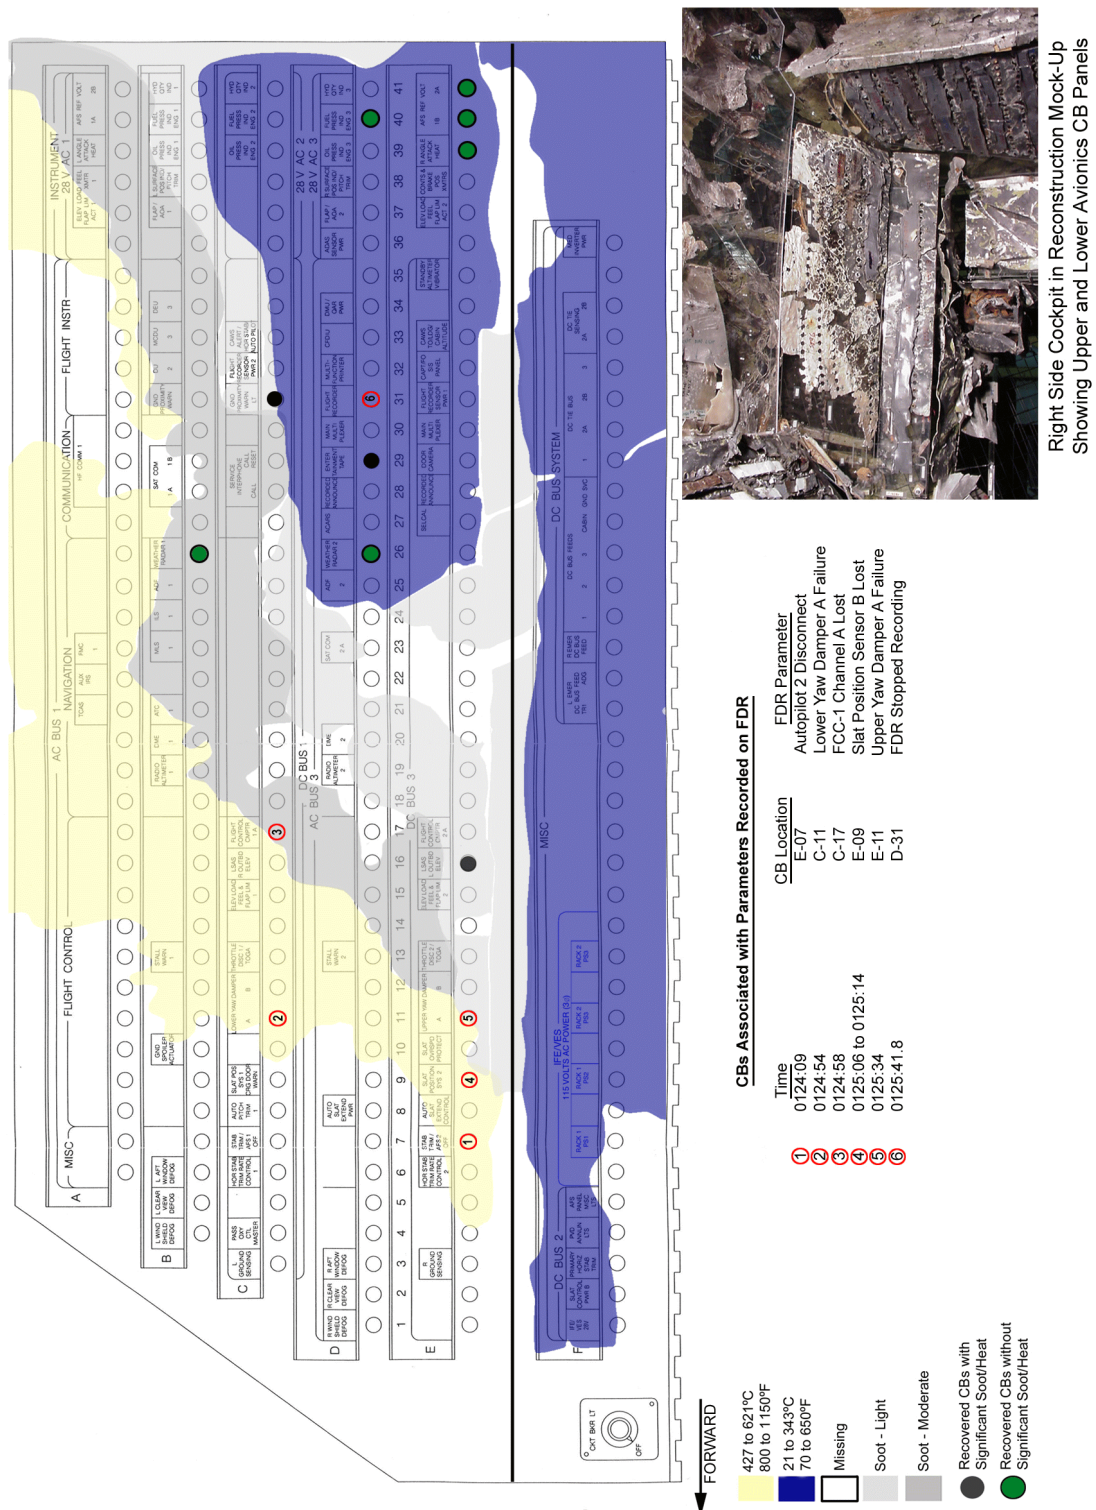
**Figure 28:** Heat damage – upper and lower avionics CB panels

side, particularly on those pieces near the forward end of the panel where the front side of the panel showed considerably more heat damage than the back side. Individual CBs showed soot on the white indicator ring; soot could only have been deposited if the CB had tripped and subsequently been exposed to combustion by-products. Details concerning the CBs on the avionics CB panel and wiring in the vicinity are included in separate sections of this report.

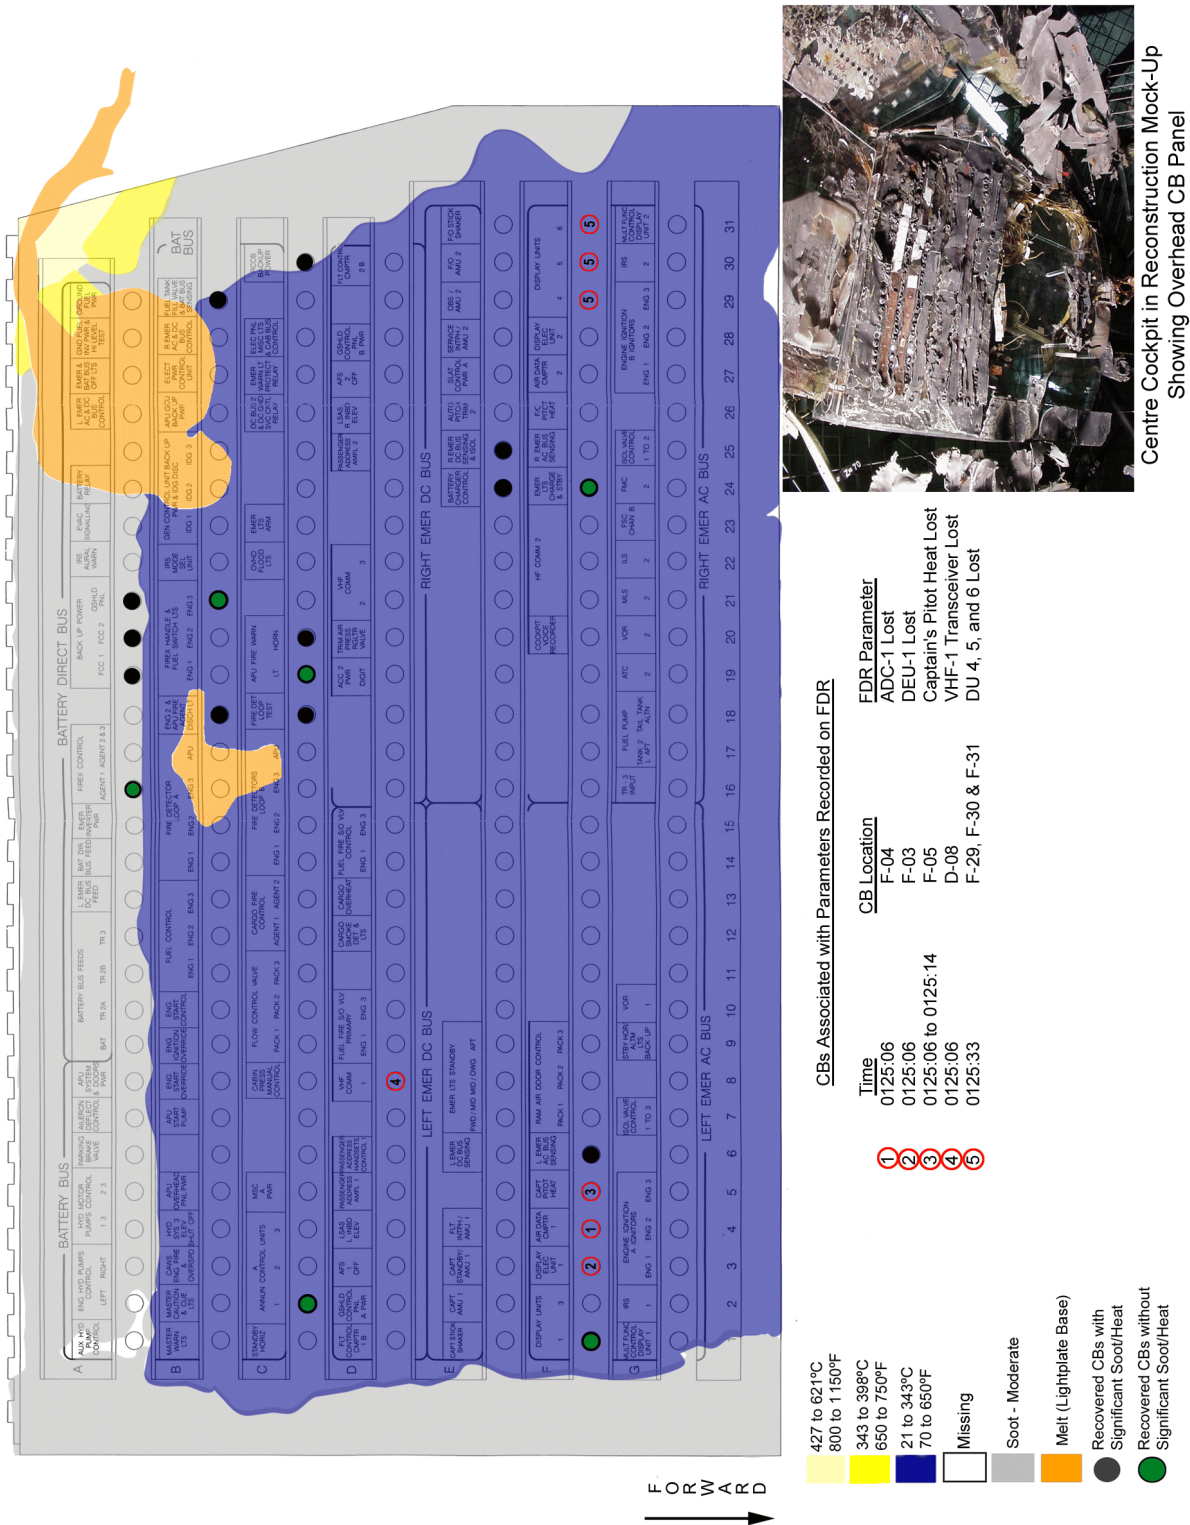
Figure 29: Heat damage – overhead CB panel

segments from the heat-damaged area helped define the heat pattern and boundaries of the fire. There were wires from the area of the fire that had no discernible damage. There was a range of damage on other wires, from light soot, to complete melting and destruction of the wire insulation.

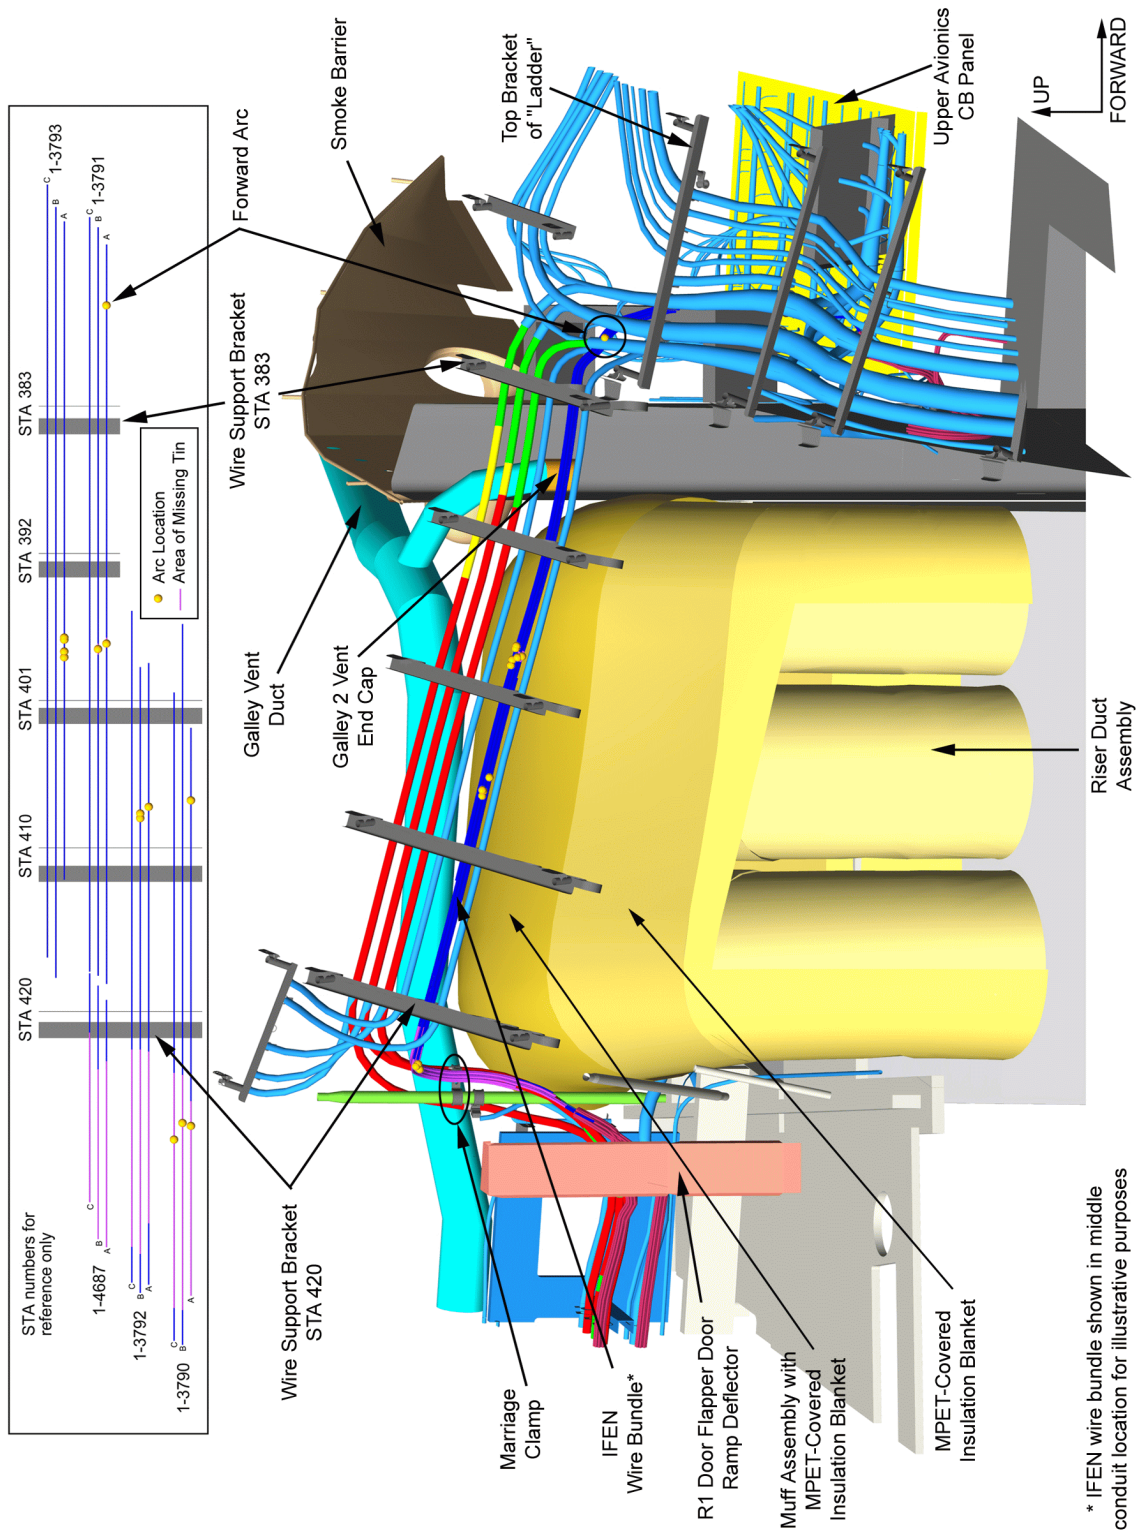
**Figure 31:** Position of recovered IFEN wires – middle conduit

The region of missing tin represented an area of higher heat. If this had been an earlier event, it is strongly suspected that all three cables would exhibit similar arcing events in the vicinity of 1-3790 outside the aft end of the conduit. With the cables and control wire laid out as described above, all of the regions of melted copper could be attributed to arcing events between phases on the same cable, between the cables and the control wire except for the arc event that took place at the forward end of 1-3791, or both. There was no matching arc damage on cable 1-3793 in this area. However, the continuation of exhibits 1-3790/1-3792 from approximately STA 401, along with the 16 AWG control wire forward, were not identified. Therefore, no determination could be made with respect to exactly what the single wire from 1-3791 had come in contact with at the forward end.
