# **Final Report of the Transportation Safety Board of Canada**

to the aircraft McDonnell Douglas MD-11, HB-IWF (SR111)

### In-Flight Fire Leading to Collision with Water

Report Number A98H0003

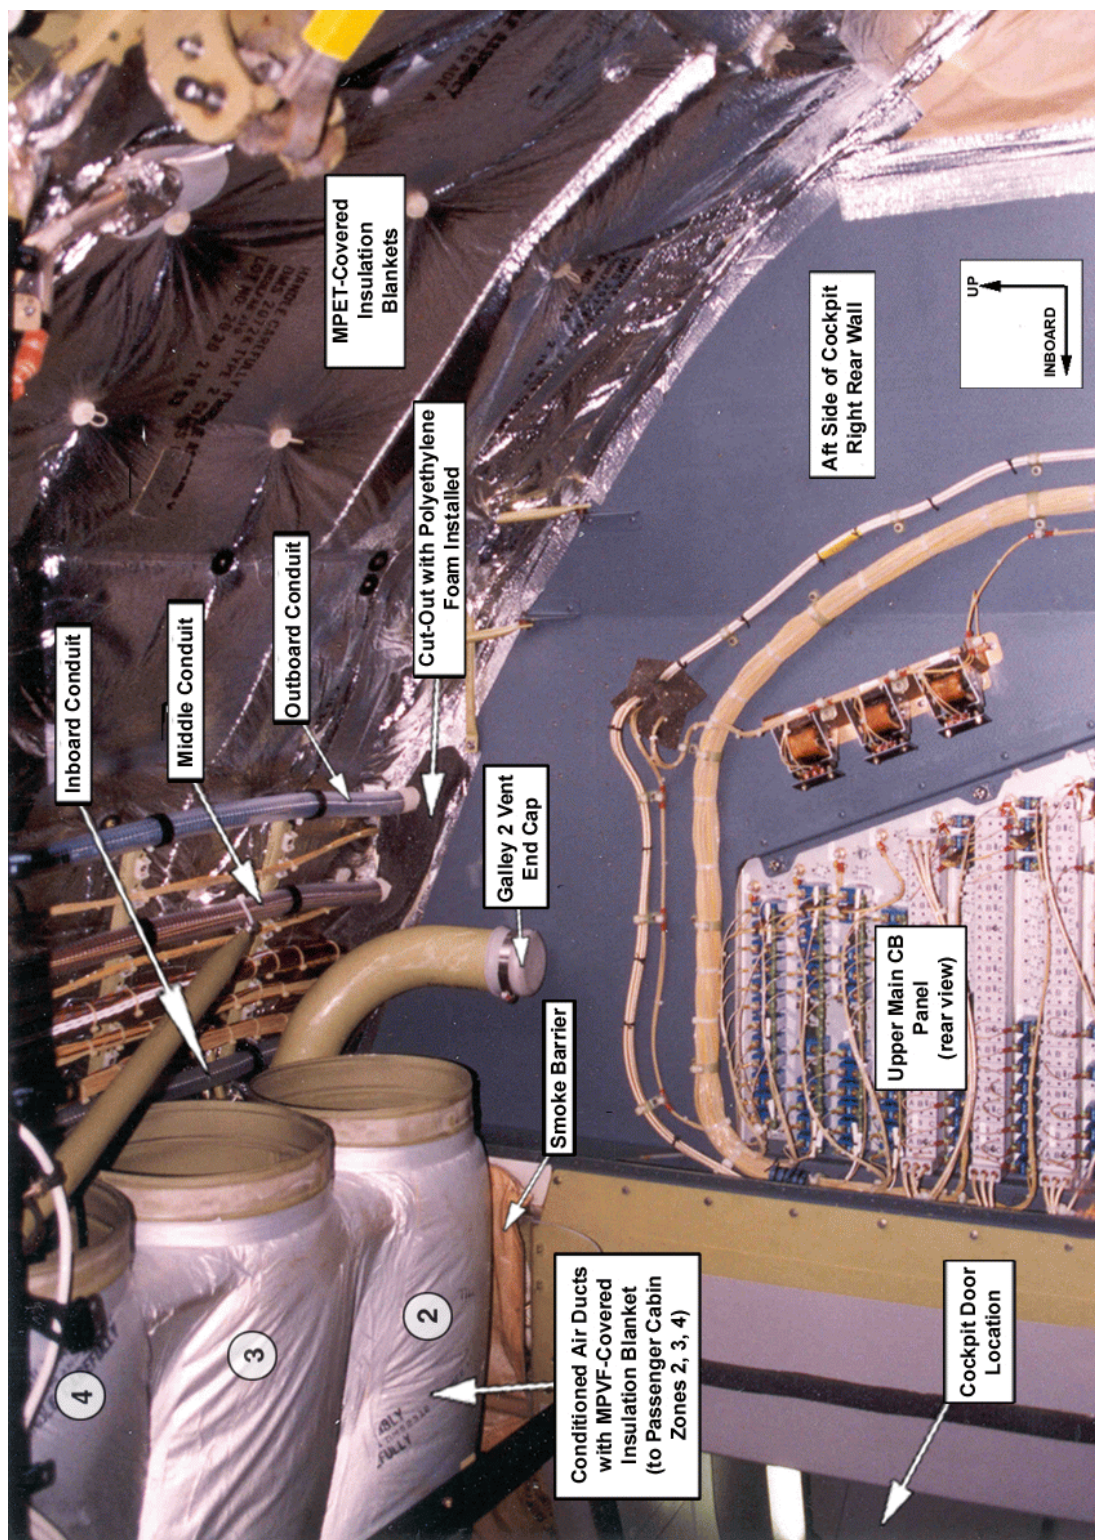
Figure 4: Area behind cockpit rear wall (Galley 2 and riser duct assembly removed)

Examination of other Swissair MD-11 aircraft in the Swissair fleet disclosed that openings existed in the smoke barriers, and in areas adjacent to the barrier. Some of these openings were located at conduit and wire run locations that pass through or above the cockpit rear wall. The top edge of the rear, right cockpit wall near STA 383 has a cut-out in it to permit the passage of wire bundles and conduits. (See Figures 4 and 5.)

Three 102-centimetre (cm) (40-inch) long conduits<sup>14</sup> and five wire bundles pass over the cockpit rear wall at this point, and continue aft over the top of Galley 2 between STA 383 and STA 420. (See Figures 3, 4, 5, and 7.) The ends of the conduits were not required to be sealed and were found unsealed in other MD-11 aircraft that were examined. These conduits and wire bundles are attached by straps to a series of wire support brackets located at STA 383, 392, 401, 410, and 420. The wire bracket positioned at STA 383 is at a slight angle relative to the cockpit wall, which is directly below it. The top edge of this bracket, and attached wire bundles, are in contact with the metallized polyethylene terephthalate (MPET)-covered insulation blanket. Each of the conduits protrude forward of the cockpit wall by varying amounts because of the angle of the wall to the bracket.

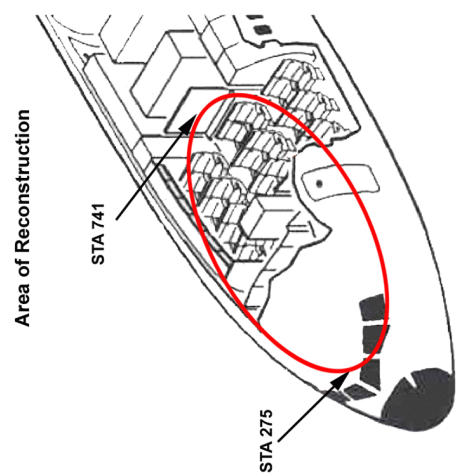
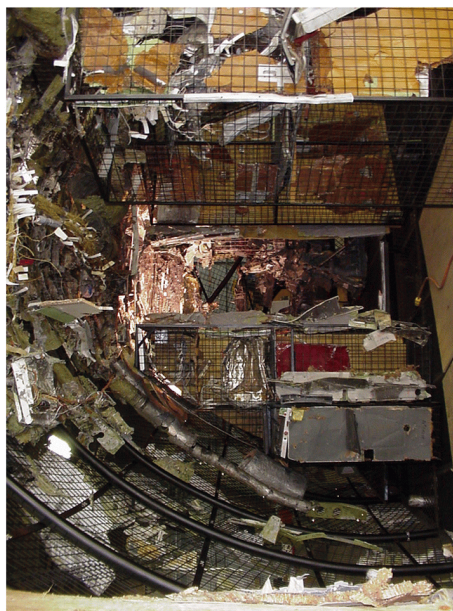
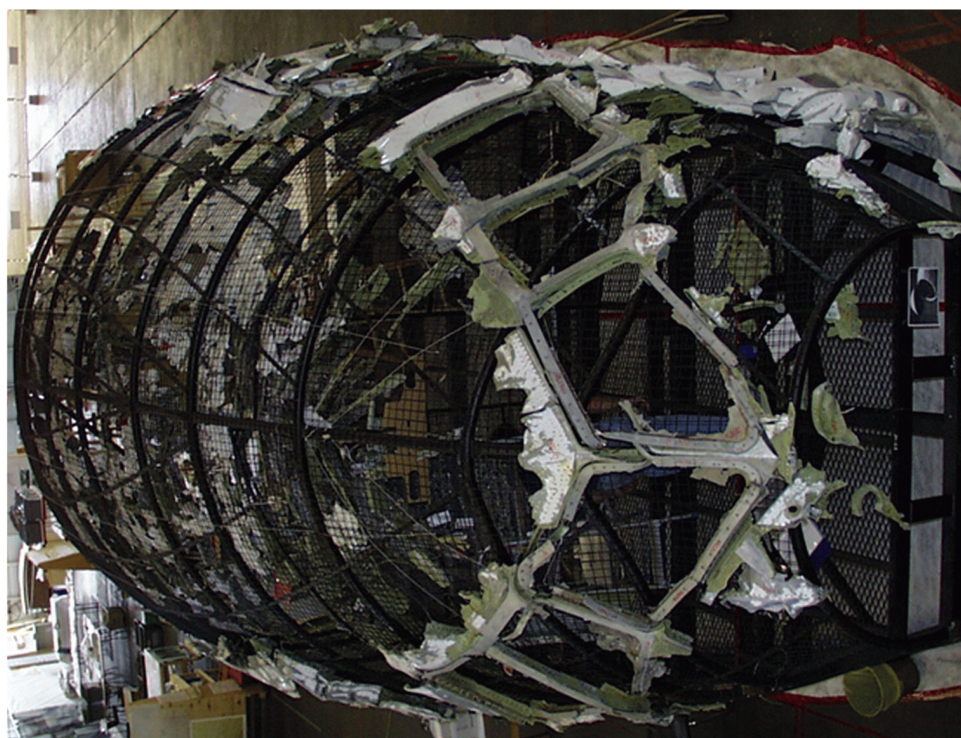
**Figure 19:** Reconstruction mock-up

The aircraft wiring was severely damaged by the forces of impact. Additional mechanical damage could have occurred to some of the wiring during recovery operations. Many of the wire segments had been broken into segments between 10 and 100 cm (4 and 39 inches) long.

All of the recovered wires were examined, primarily to identify any with signs of melted copper. As the fire did not reach temperatures high enough to melt copper,<sup>50</sup> any areas of melted copper would indicate that an electrical arcing<sup>51</sup> event had occurred.

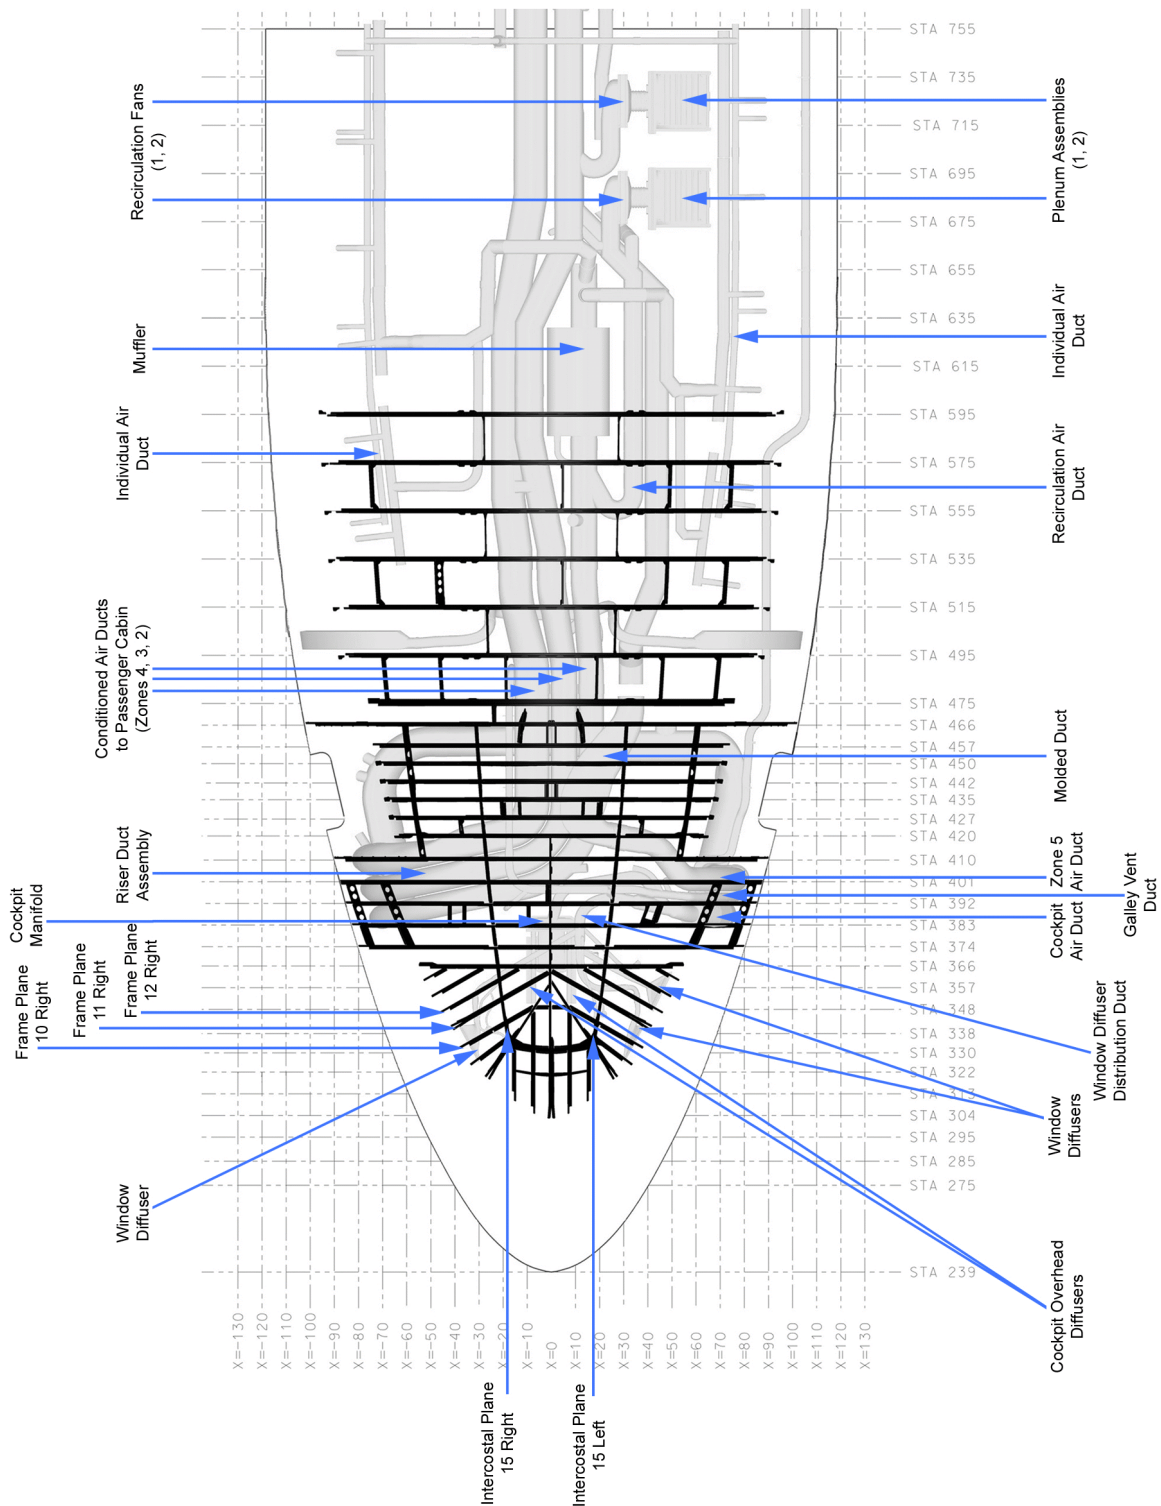
**Figure 24:** Airframe structure and air distribution system

There was bare-metal heat damage on the ducts behind the cockpit air diffusers from STA 350 aft to STA 402, primarily between the plane 15 left and right intercostals. The exception was the window diffuser distribution duct, which had bare-metal heat damage along STA 392 to  $X = 32$ . The heat damage to the recovered portions of the diffusers varied, with higher heat on the upper surfaces and lower heat on the lower surfaces adjacent to the cockpit ceiling liner.

Damage to the riser duct assembly ranged from no heat damage to bare-metal heat damage. The vertical portion of this assembly had no heat damage. The first area of bare-metal damage to the riser duct assembly started at intercostal plane 15 right, where the lower surface had a region of bare-metal heat damage from  $X = -30$  inboard to the joint at  $X = -20$ . This was in the vicinity of the Galley 2 vent end cap. There was bare-metal damage from approximately STA 395 to STA 442 between  $X = 25$  and  $X = -10$ . A section of molded duct was installed in that area from STA 420 to STA 442 between  $X = 5$  and  $X = 25$ . No portions of this molded duct were identified in the wreckage.

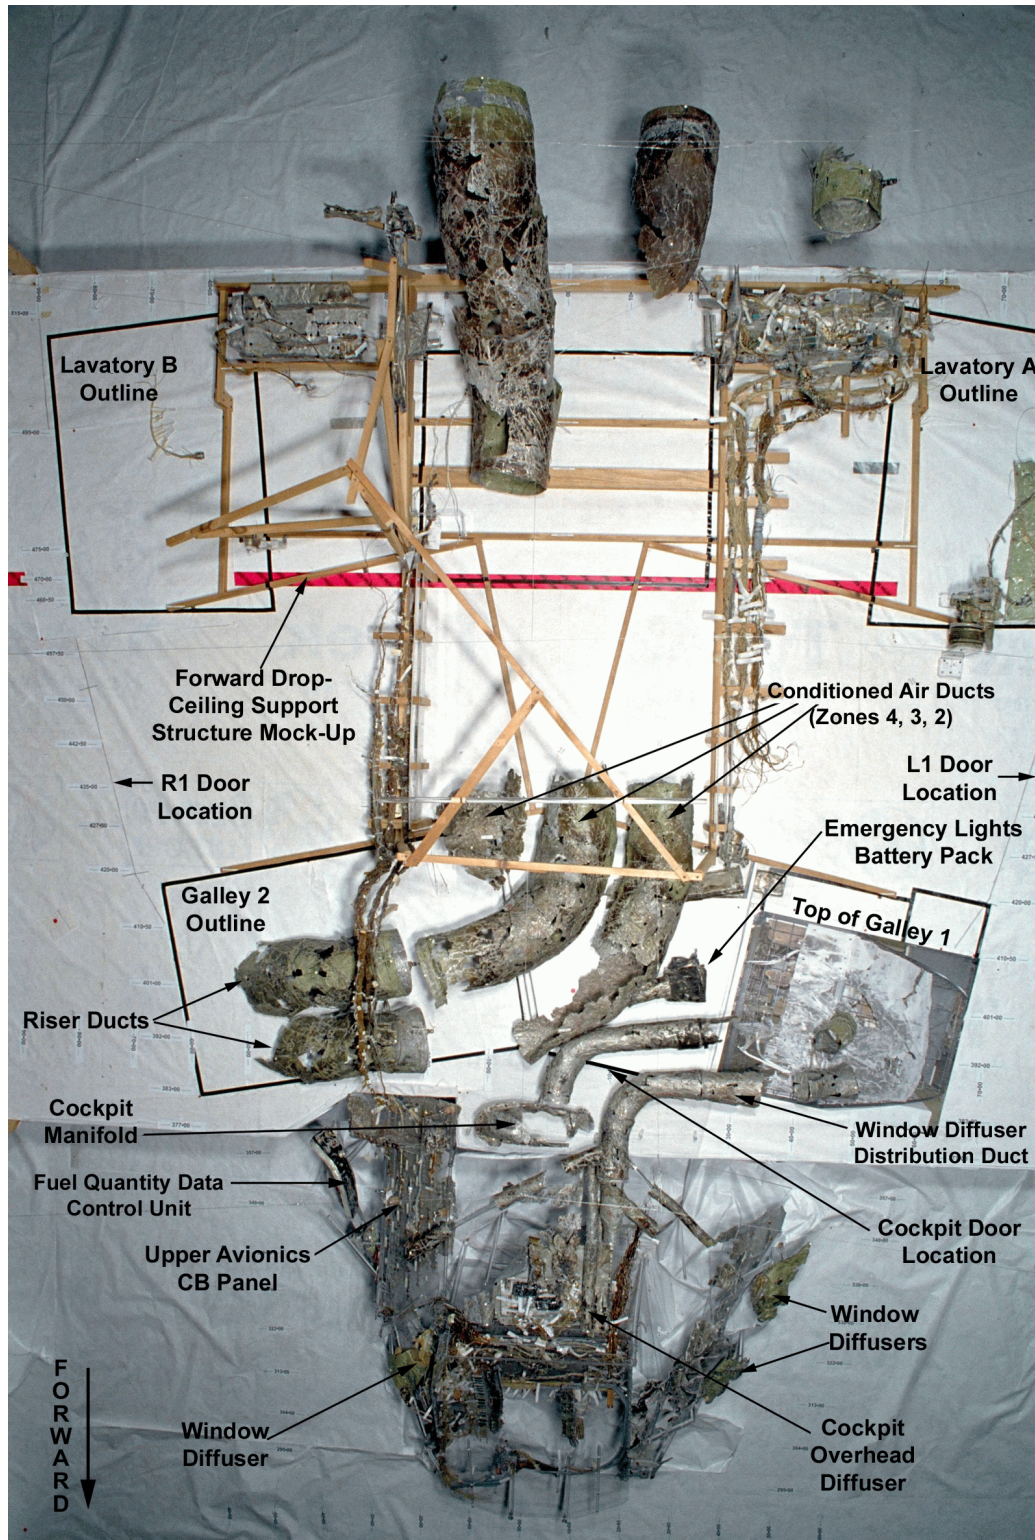
Figure 27: Cockpit attic and forward cabin drop-ceiling areas mock-up

About 75 per cent of the upper and lower CB panels were identified, reconstructed, and placed in the reconstruction mock-up (see Figures 27 and 28). The most forward sections of the upper and lower CB panels were not recovered. The upper avionics CB panel had been exposed to heat coming from both the front and back sides. The lower CB panel did not show any heat damage. The heat damage pattern on the front face of the upper CB panel was shown by the change in colour of the paint. Parts of the panel displayed damage consistent with temperature reference exemplar coupons exposed to temperatures from 430°C to 620°C (800°F to 1 150°F) for 10 minutes.<sup>67</sup> Discolouration and heat damage was present on the back side of this panel on some electrical components and on some bare-metal surfaces. Although there were similarities at some locations, the damage pattern on the back side was less than on the front

side, particularly on those pieces near the forward end of the panel where the front side of the panel showed considerably more heat damage than the back side. Individual CBs showed soot on the white indicator ring; soot could only have been deposited if the CB had tripped and subsequently been exposed to combustion by-products. Details concerning the CBs on the avionics CB panel and wiring in the vicinity are included in separate sections of this report.

Most of the CB panel was identified, reconstructed, and placed in the reconstruction mock-up (see Figures 27 and 29). On the cockpit-facing surface, approximately two thirds of the polycarbonate lightplate base on Row A had been melted and folded back over onto itself, forming a fused mass of material near the top right corner of the panel. Part of the right end of the lightplate base on Row B was also melted and fused into this mass. The top right corner of the panel where the paint was missing had heat damage consistent with temperature reference coupons that were exposed to temperatures from 427°C to 621°C (800°F to 1 150°F) for 10 minutes, and the area where the paint was discoloured had heat damage consistent with temperature reference coupons that were exposed to temperatures from 343°C to 398°C (650°F to 750°F) for 10 minutes. The rear surface of the panel also showed signs of localized high-heat damage at the top right corner.

Examination of the battery pack showed that, although it was extensively heat damaged, the heat occurred from the outside in (see Figure 27). This indicates that the fire did not start from a heat condition, such as thermal heating, within the battery pack.
